# RealSense™ Product Family

## D500 Series

Specification Update

Revision 002

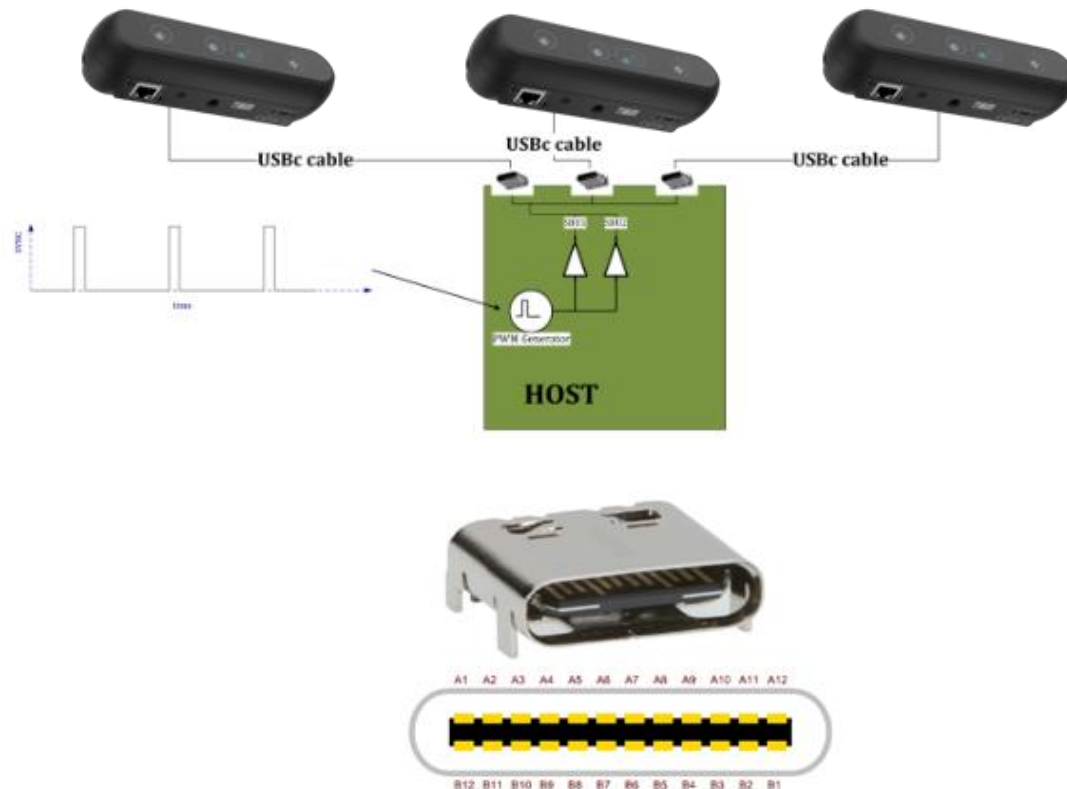
### 4.1 External HW Sync

- Multiple cameras can be connected to one host and will be able to stream asynchronously independent data
- The cameras can be hardware synchronized (HW sync) so they capture at exactly the same time and rate
- The host will be the synchronization master, and the cameras will be working in slave mode
- An SDK API will be used to configure the cameras in slave mode
- The main difference between the D400 (Vision Processor V1 and V3) HW sync and D555:
- D400 cameras HW sync use the 9pin aux connector—pins 5 (SYNC) and pins 9 (Ground)
- D555 will use the USB type C connector 2 SB (sideband) pins, requiring connecting a USB type C connector on the host side as well
- Note: The RGB color sensor is synchronized with the depth sensors (left and right) when they stream at the same FPS

Number	Status	Errata
	Open	USB is supported for debug and production line or HW Sync.
RSDEV-2744	Open	External HW Sync is supported on HW, SW support is missing. Refer to Appendix
RSDEV-3192	Open	Calibration Data is missing from Viewer
RSDEV-3293	Open	RGB-Depth UV mapping impact by thermal loop
RSDEV-3188	Open	~0.5pixel UV movement to the right for both X and Y axis
RSDEV-4775	Fixed in 7.56.19919.4144	D555: cannot be detected after changing the link-timeout setting
